# RIVER STOUR, NAYLAND

**BUT A RIVER IN NEED  
OF MAINTENANCE**

## The River Stour at Nayland; from the A134 tunnel to the Abell Bridge.

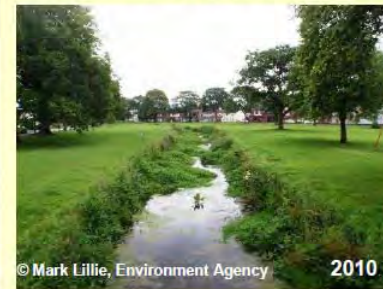
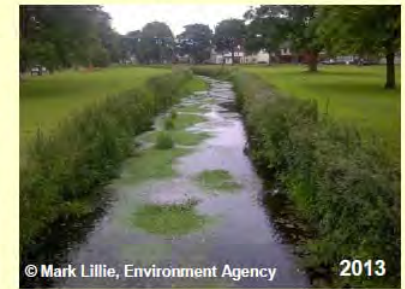
##### Example: Brompton Beck, North Yorkshire

Brompton Beck frequently floods some of the houses in the village of Brompton near Northallerton. Lesser water-parsnip *Berula erecta* is the key problem species here as it can cover the whole channel width, reducing flow conveyance.

During high flows this relatively fragile species also dislodges, breaks up and flows downstream where it blocks the bridge at the downstream end of the village green, contributing to local flooding issues. To reduce this risk, in 2010 the beck was de-weeded using an excavator fitted with a solid bucket. Vegetation has regrown within a few years meaning repeat or alternative management is required.

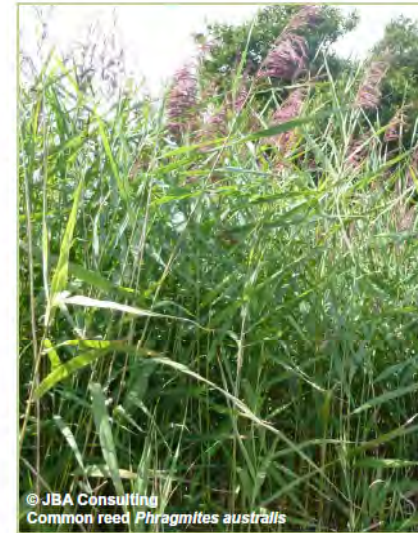
### 5.5.1 Common reed *Phragmites australis*

© JBA Consulting  
Common reed *Phragmites australis*

Common reed *Phragmites australis* is the tallest native grass species in the UK, and can grow up to 3 m in height. It has greyish-green leaves with a ligule composed of a ring of white hairs. Its flowers are dark purplish-brown in colour and are very highly branched.

This perennial species spreads through creeping rhizomes, which can grow up to 1 m below ground level. Common reed can cover large areas of swamp and fen, as well as forming dense stands within watercourses within the riparian zone. It can grow in both static and flowing waters. It is found throughout the UK, but is most common in lowland areas where it is a frequent species in the shallower waters of rivers and lakes, growing in water depths of up to one metre. It can also grow on areas of drier land which are only seasonally inundated.

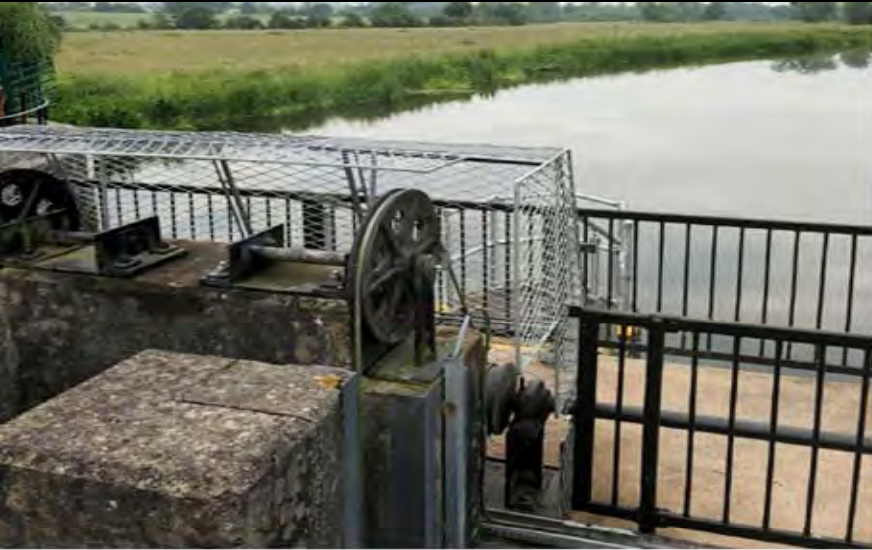
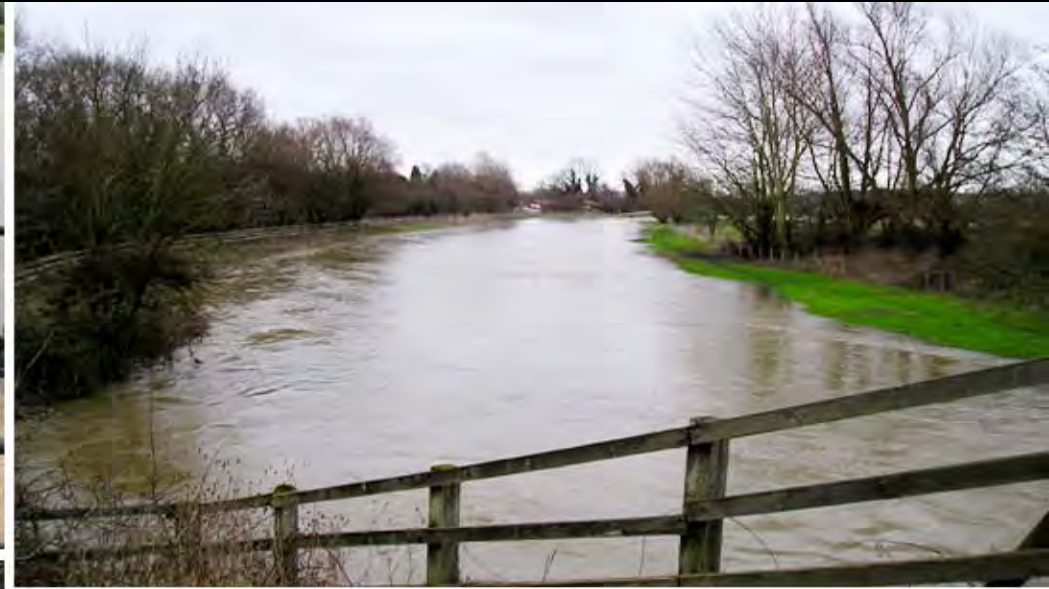
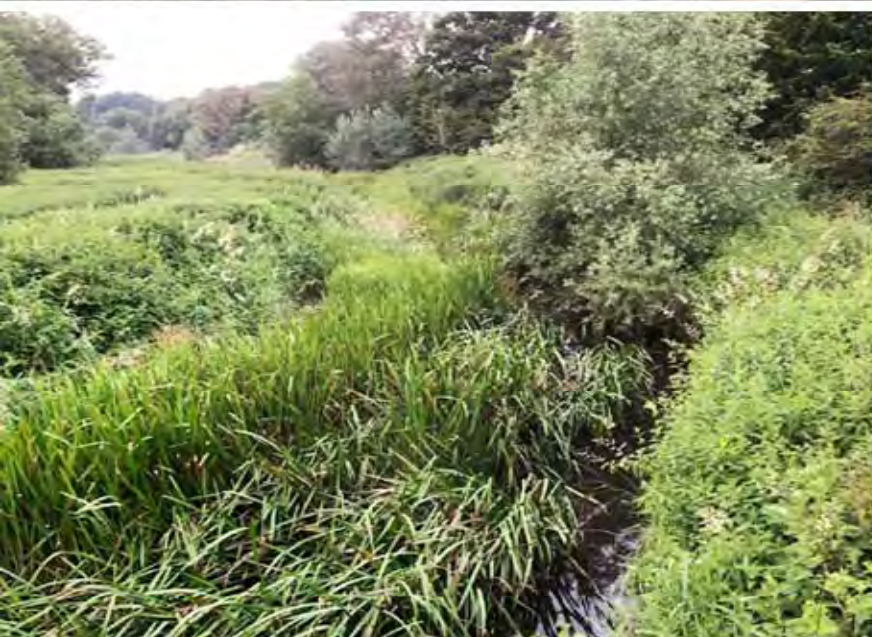
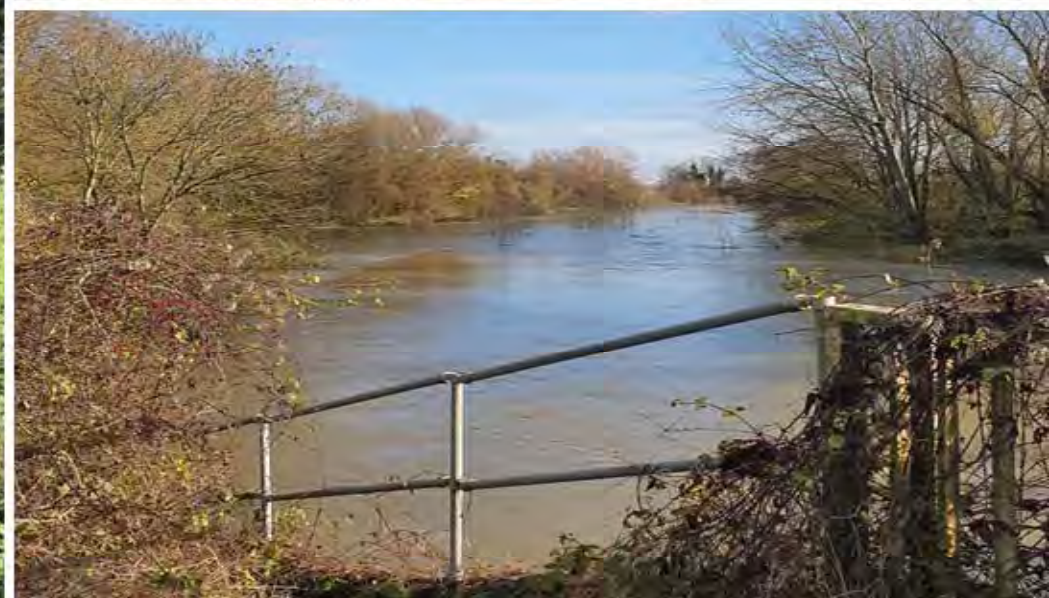
# The Sluice Gates & Excess Vegetation in the Flood Channel

The Sluice Gates divert high levels of water away from the village via the Flood Channel, but this has become overgrown so its capacity reduced. In 2008 (top right) it worked more efficiently than in 2020. Reeds are not a problem above the sluice gates as the water is deep which restricts their growth to along the river bank.

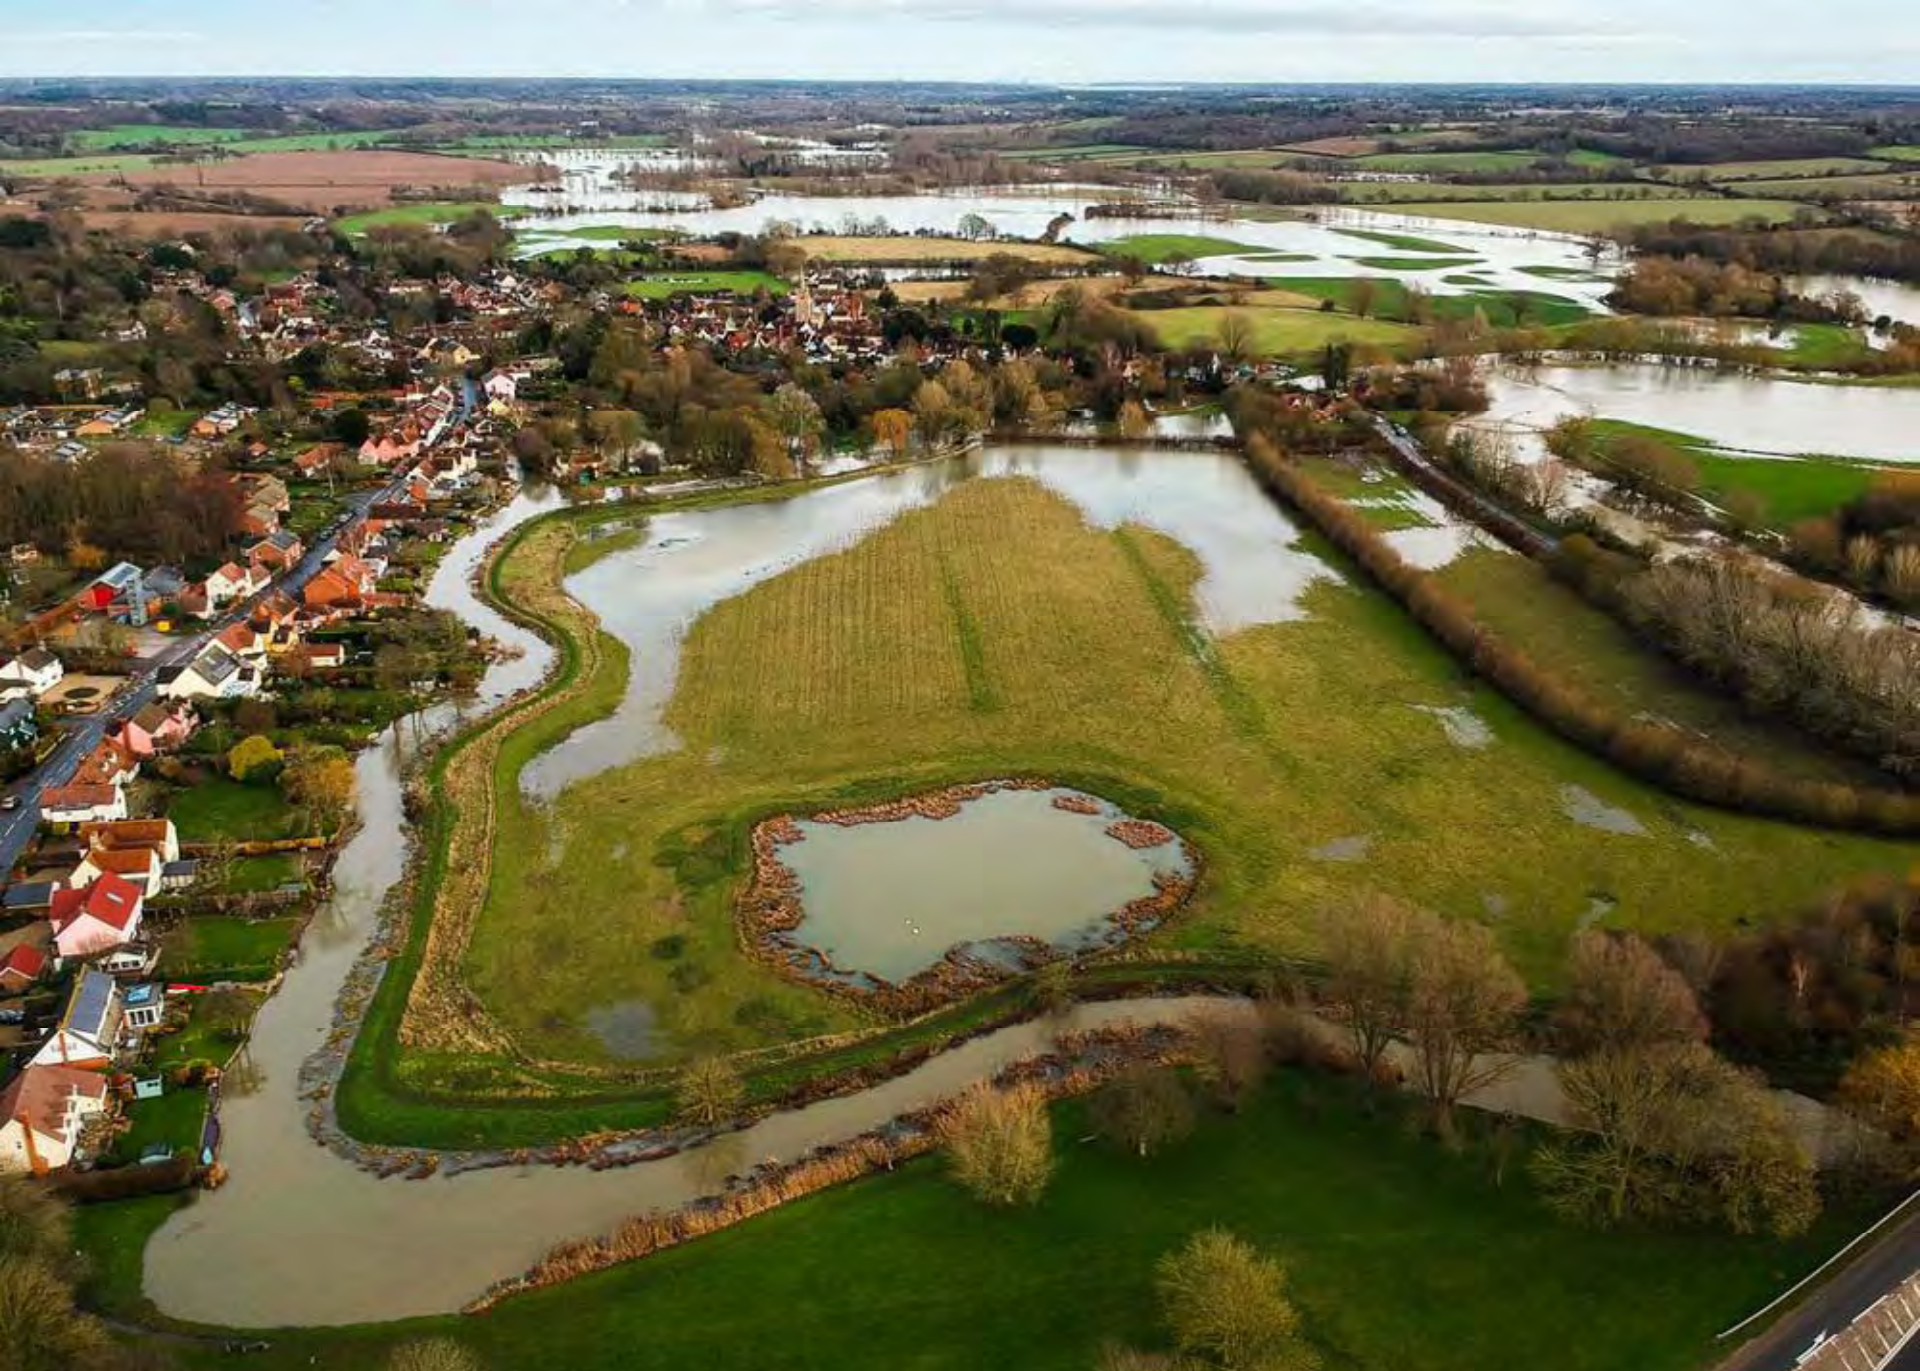
It has been noticed flood water has extended to areas it did not previously flood

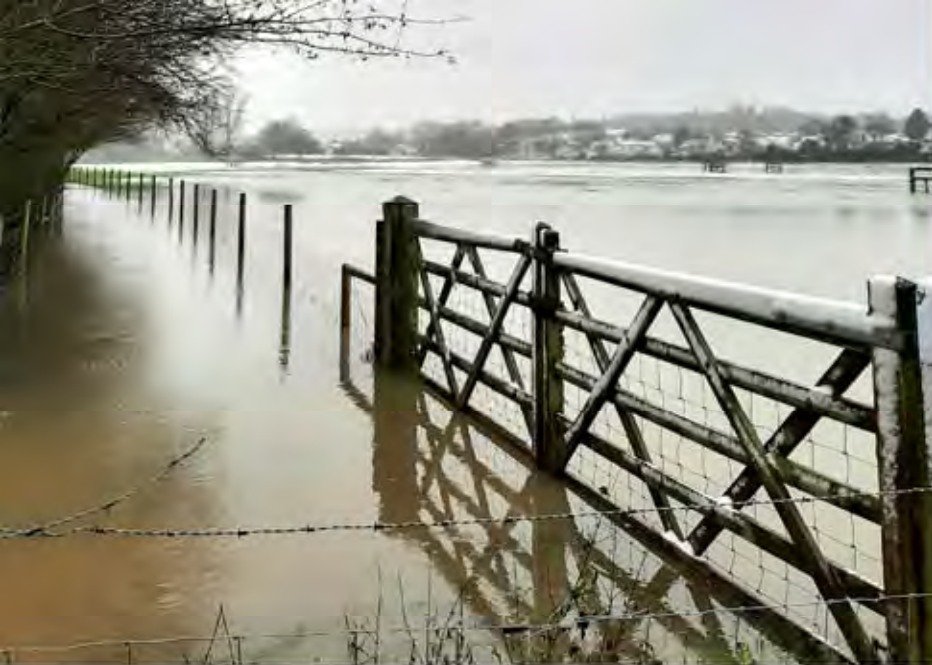
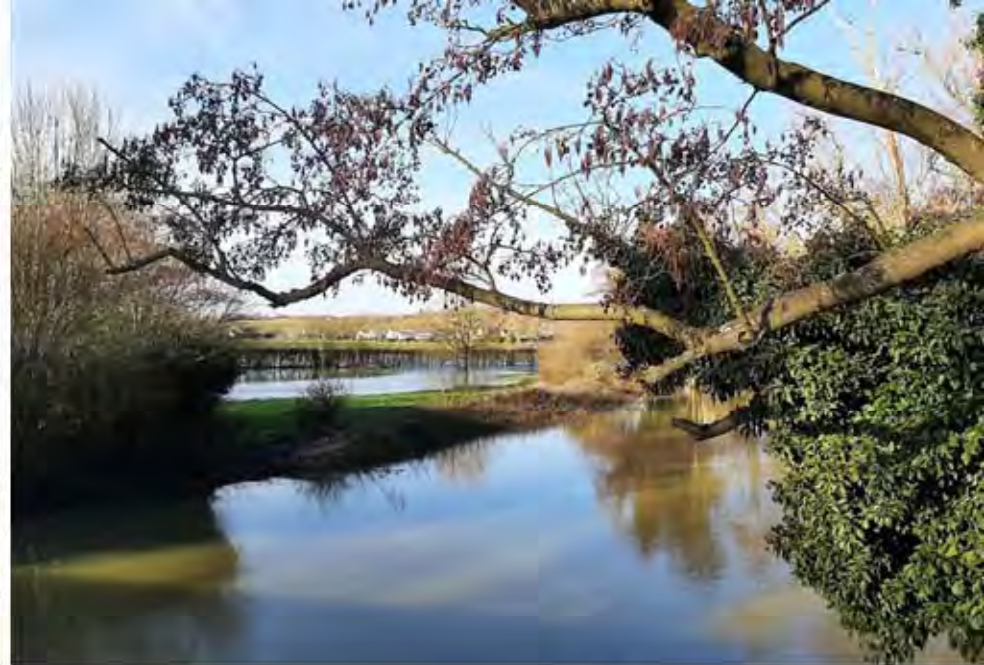
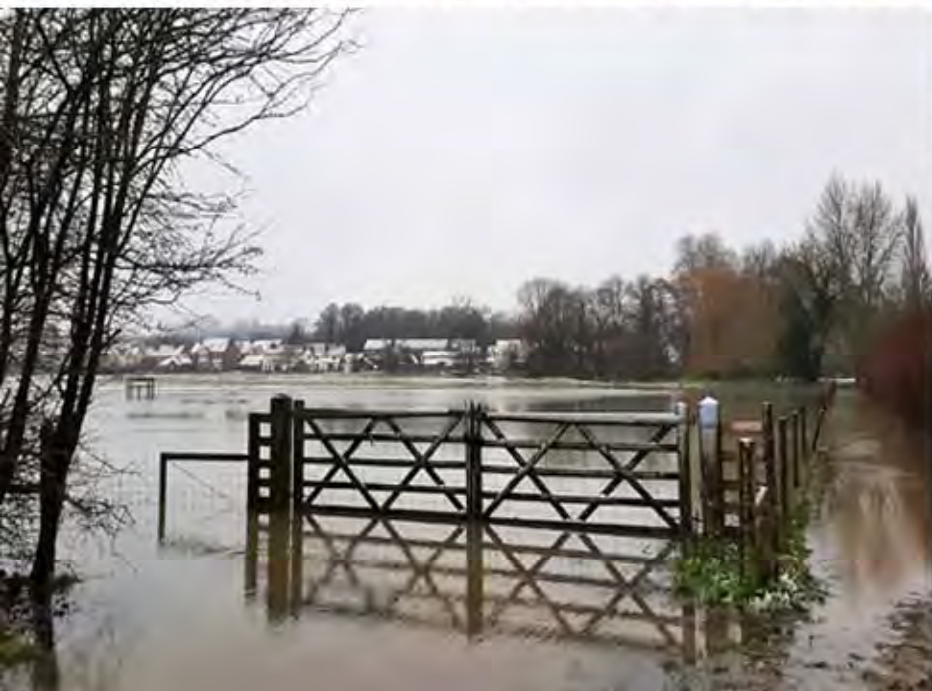
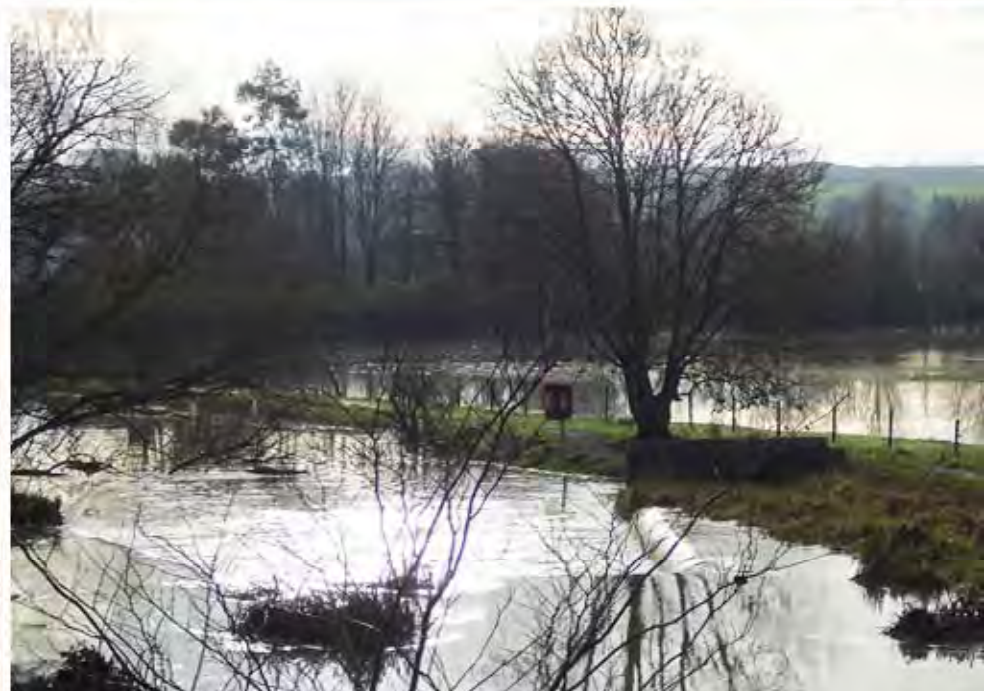
Flood waters now affect the area North of the Flood Channel and Horkesley Road onto Nayland Meadow.

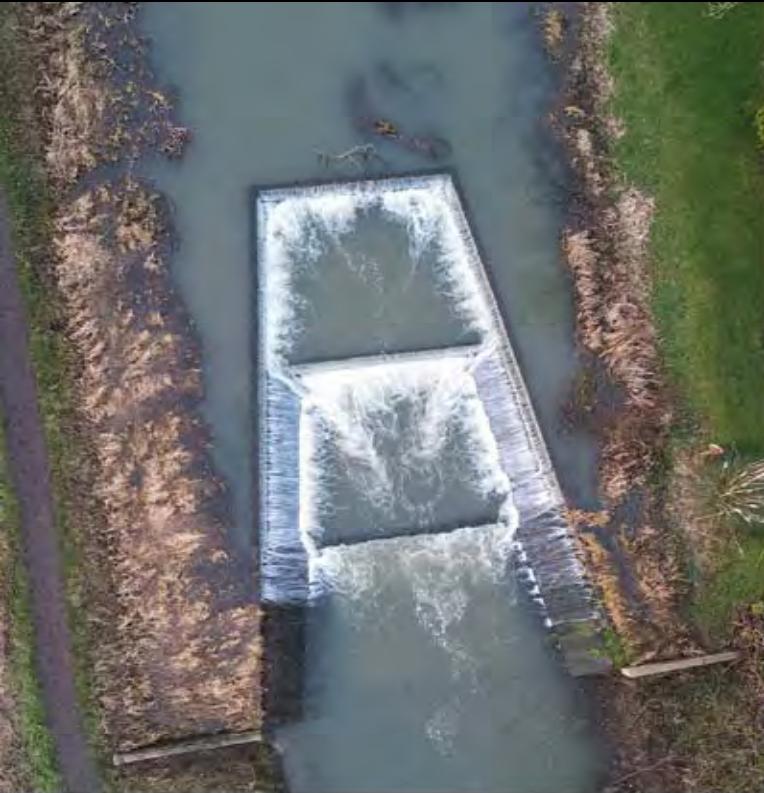
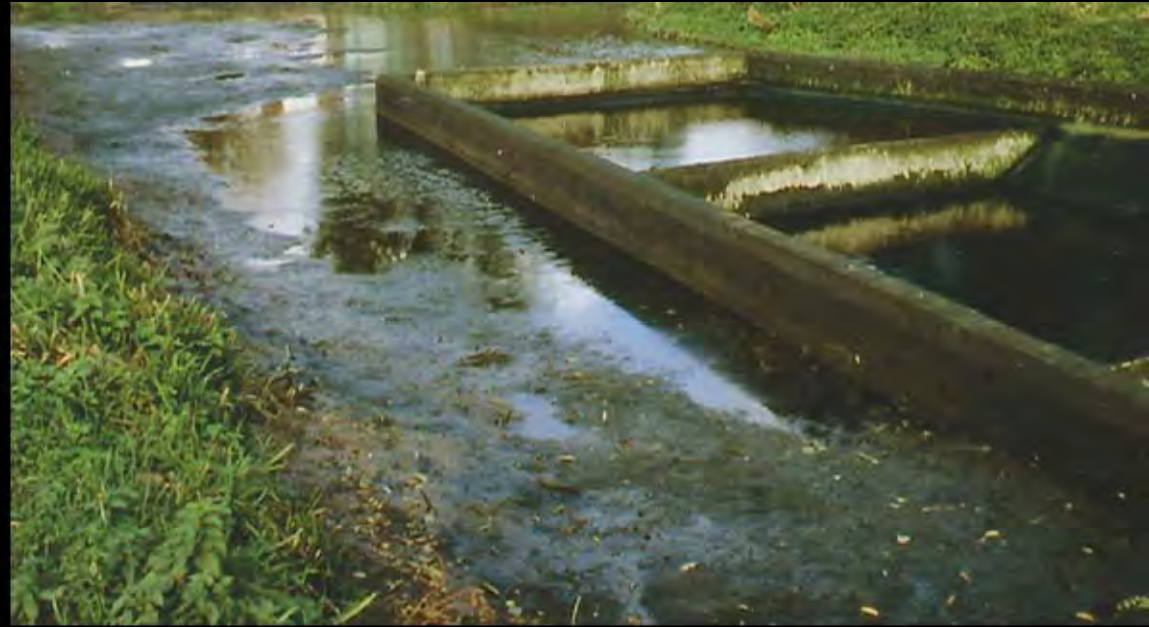
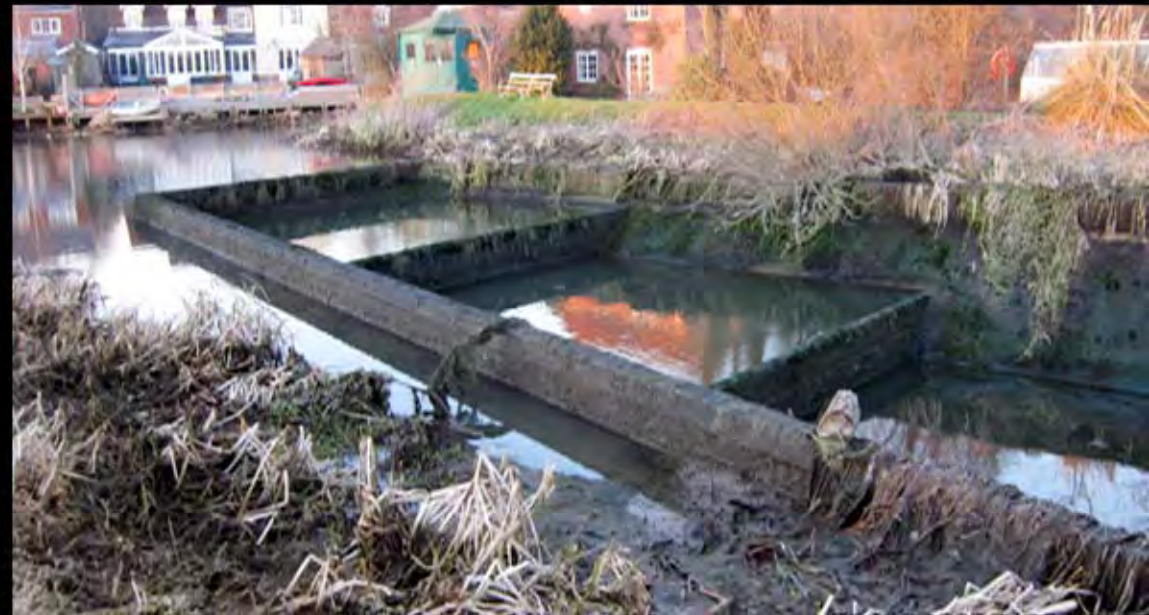
## Excessive Reed Growth at the Horseshoes Weir

This aerial view of the weir reveals that reed growth is preventing water flowing over the sides at the bottom end of the weir. The other photos reveal the extent of the build up of silt.

The shallow depth of water provides ideal conditions for reeds to multiply, as they have.

The EA is the riparian owner here and therefore responsible for controlling the reeds here.

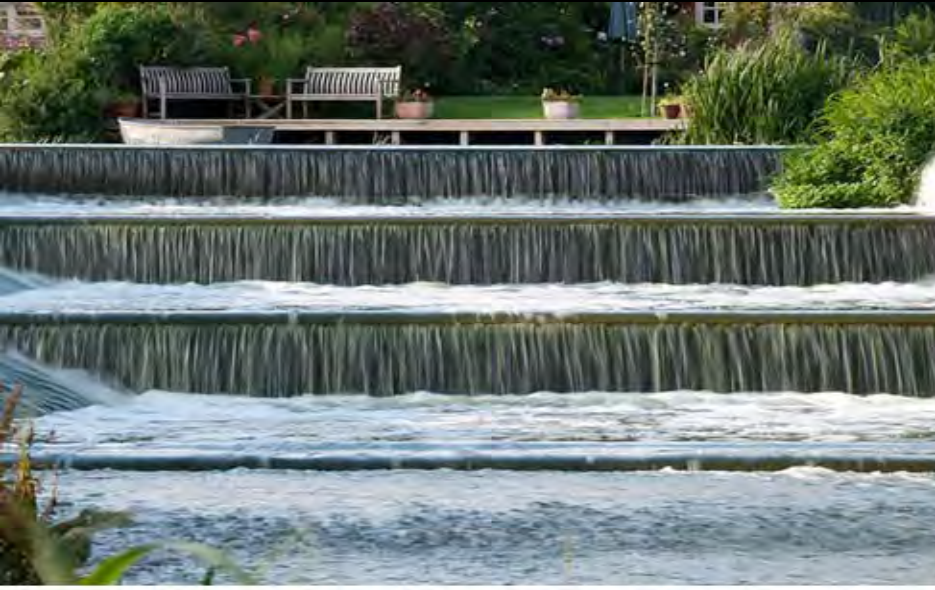
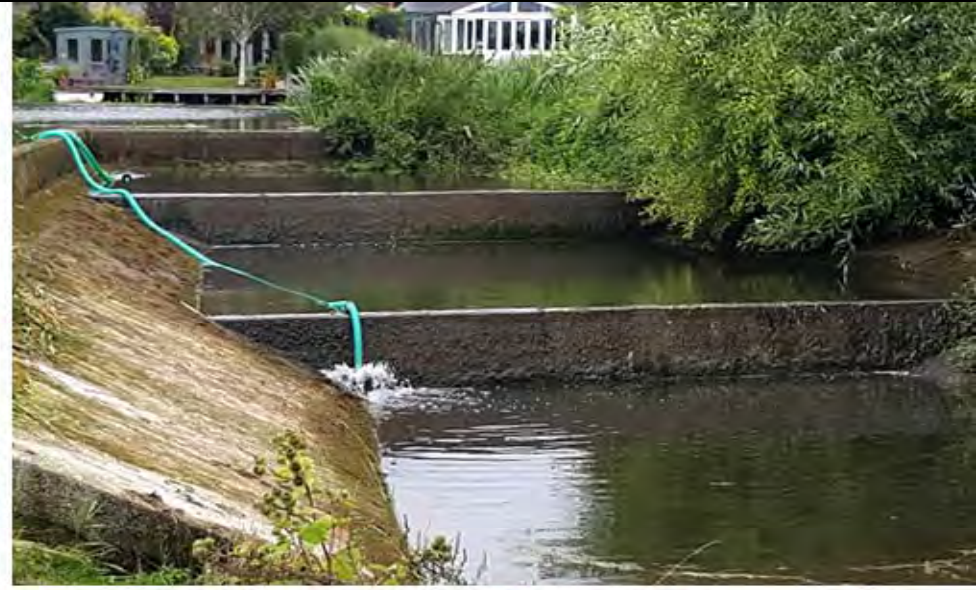
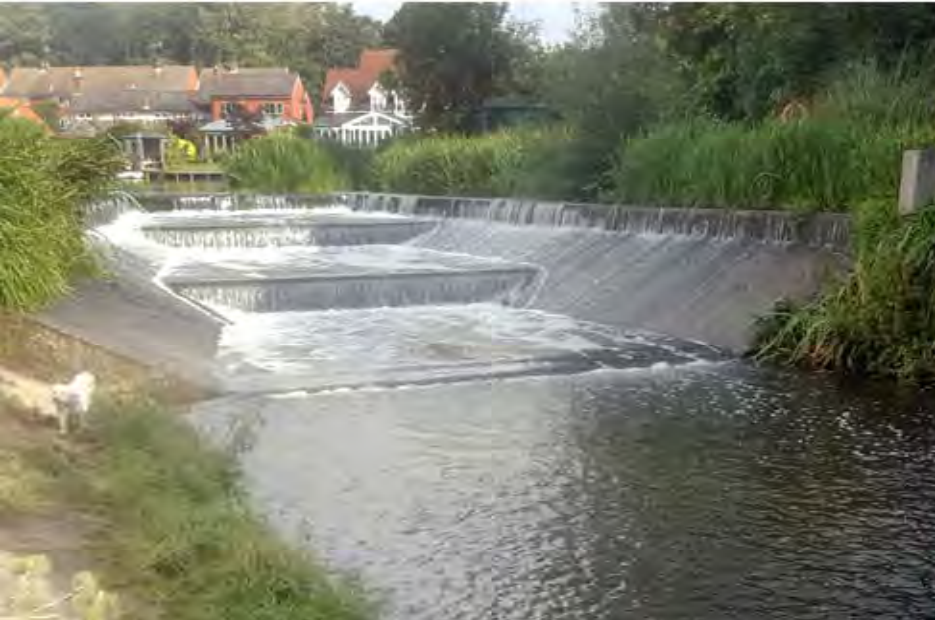
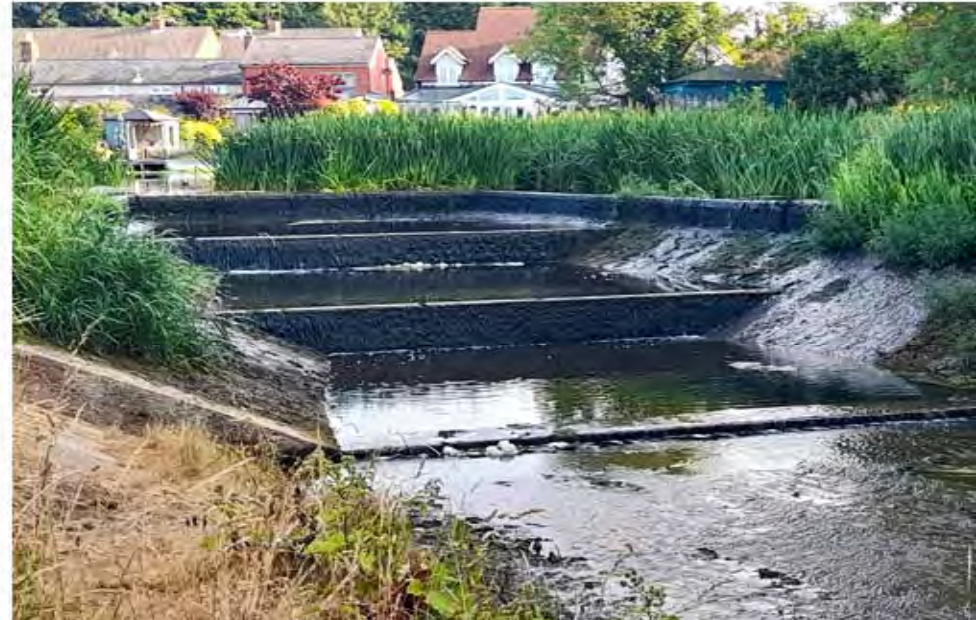
## Excessive Reed Growth at the Weir

While a neighbouring landowner has cleared some vegetation that breached the weir, residents have watched the reeds advance rapidly in these ideal growing conditions.

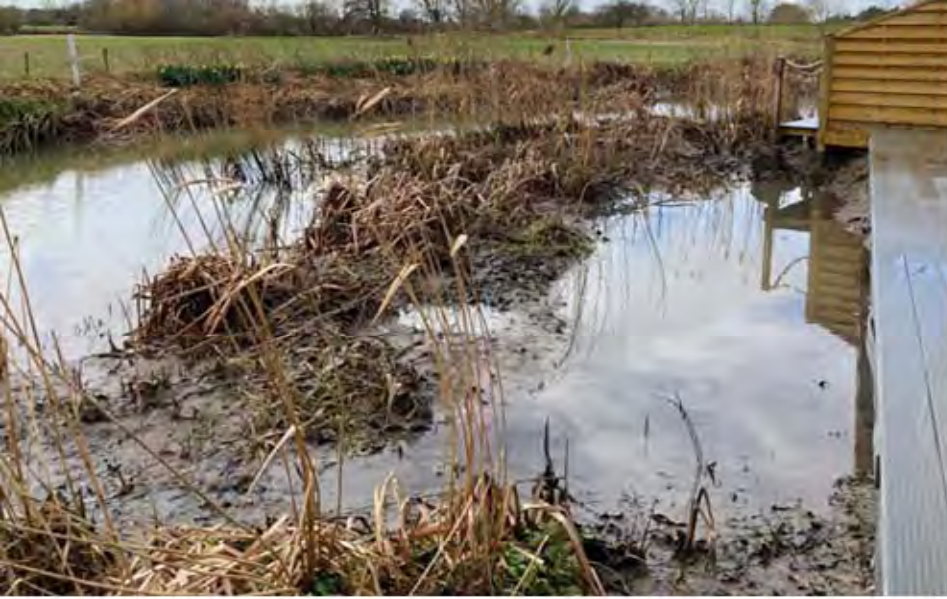
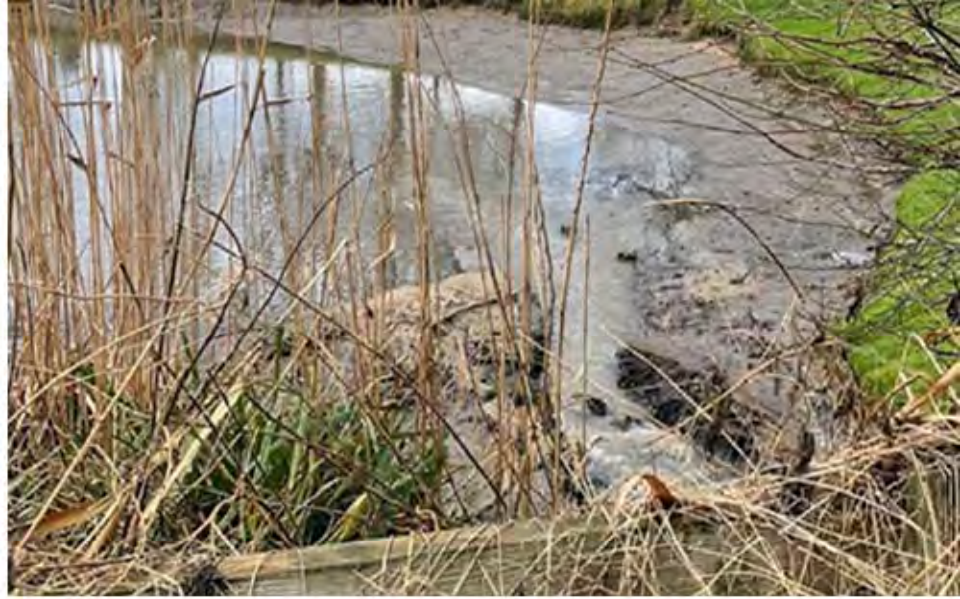
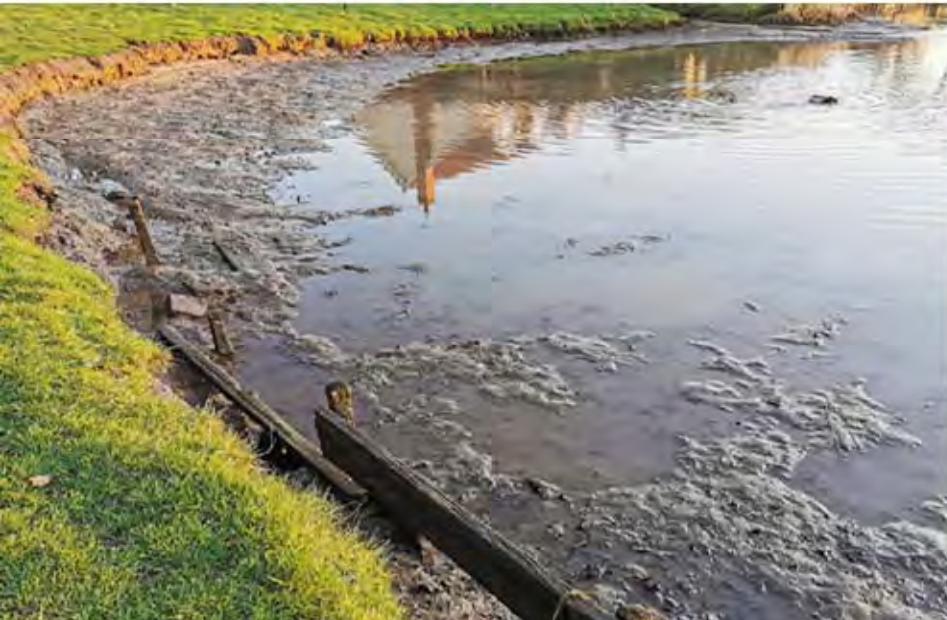
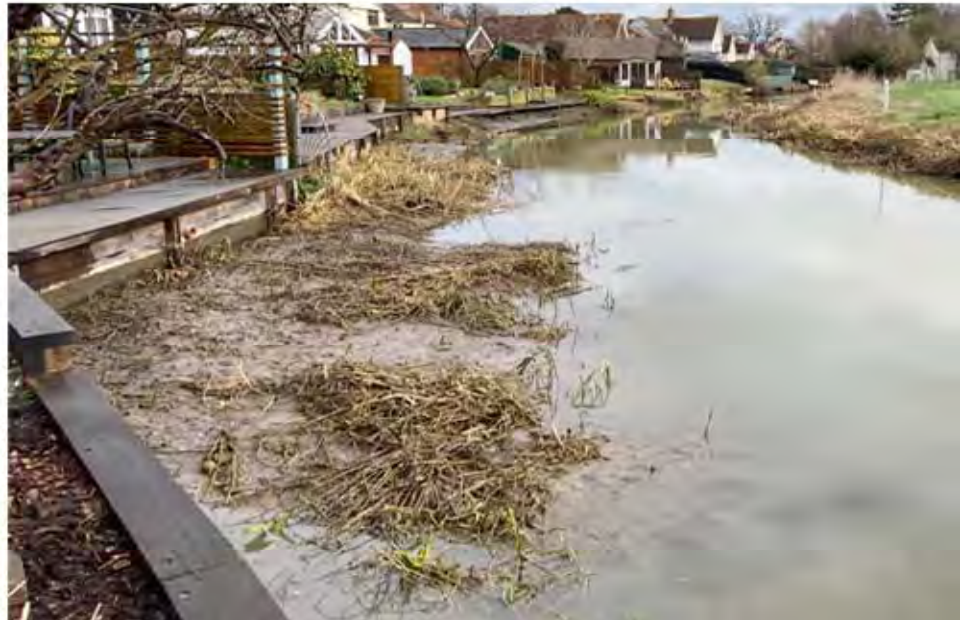
## Excessive Reed Growth & Silt

Incidents of fluctuating water levels have revealed the amount of silt and debris build up along this whole section of river. Top Right: water from a drainage ditch into the river is carving its way through the silt and sediment.

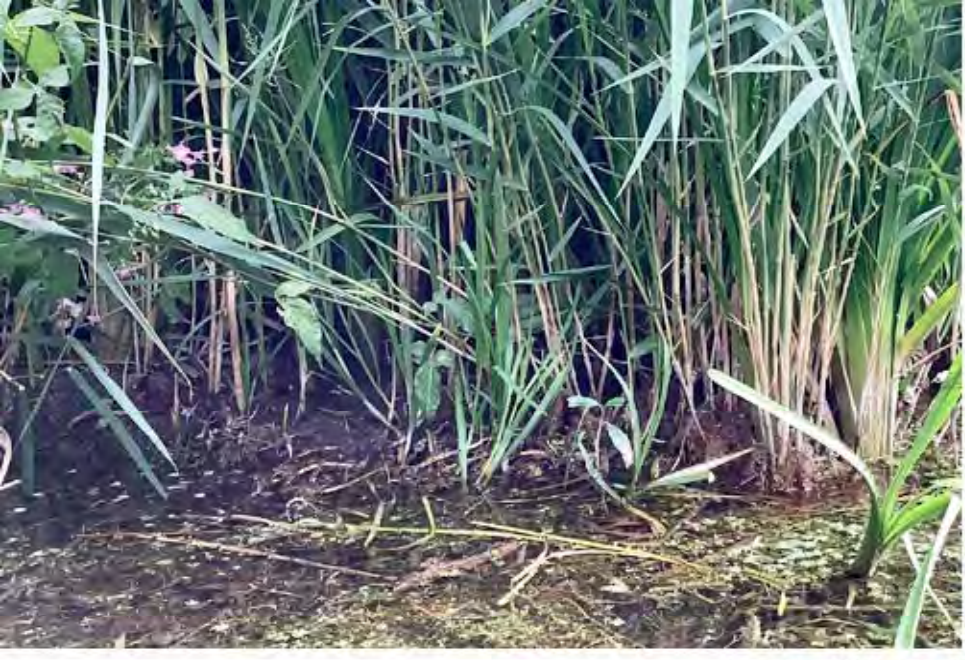
Piped water from a drain and spring runs along a short ditch into the river here; silt has built up, reeds have created a rapidly growing island. This is becoming larger and will eventually block the ditch. There are no fish fry entering here needing protection. The photo shows that the island, stretching halfway across the river is driving floating debris round the bend and to the mouth of the ditch. This will break down and increase the silt.

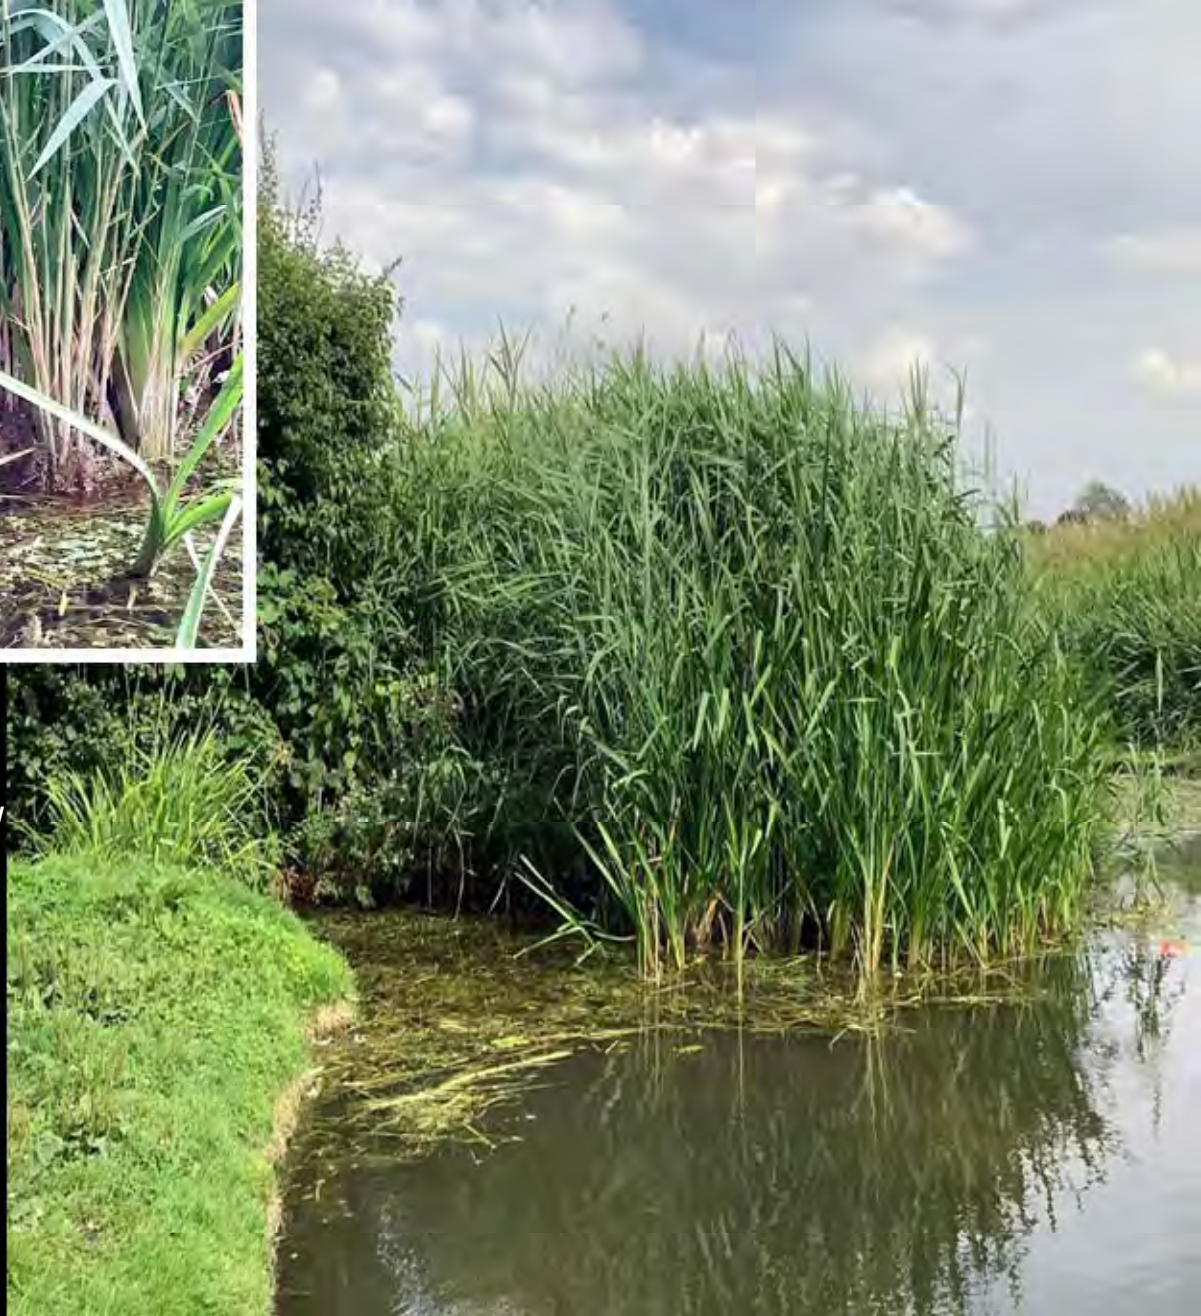
Riparian owners fight a losing battle to control this invasive vegetation. They are not permitted, even if they were able to, to carry out any silt management as that can only be carried out by the EA.

Silt removal to help riparian owners control reed growth and enable other plant species to establish; this would also increase the capacity of the river and reduce flood risk

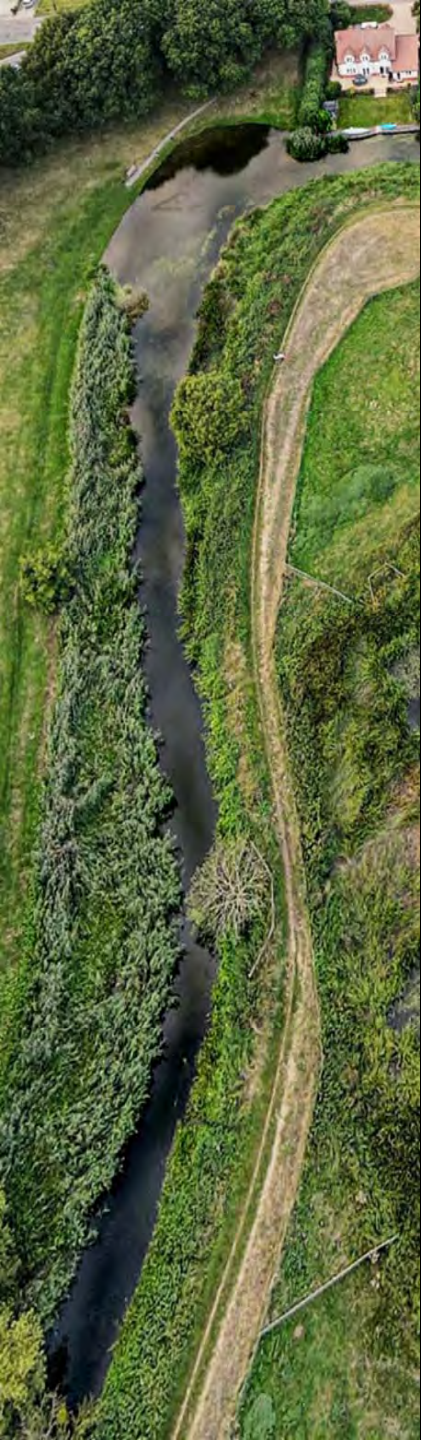
With no silt control for over 15 years reeds along the river from the A134 Tunnel to Abell Bridge are flourishing.

As can be seen (left) the river is less than half its actual width.

Fishing Rights cannot be exercised as the river cannot be seen, let alone fished.

Residents use the public open space and the riverside footpath but cannot see the river.

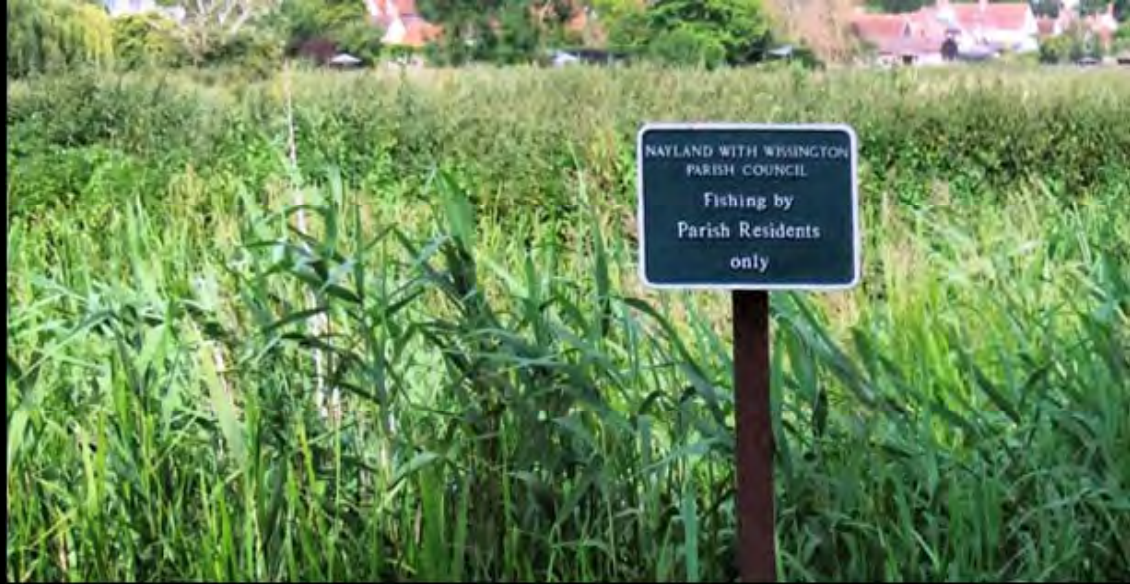
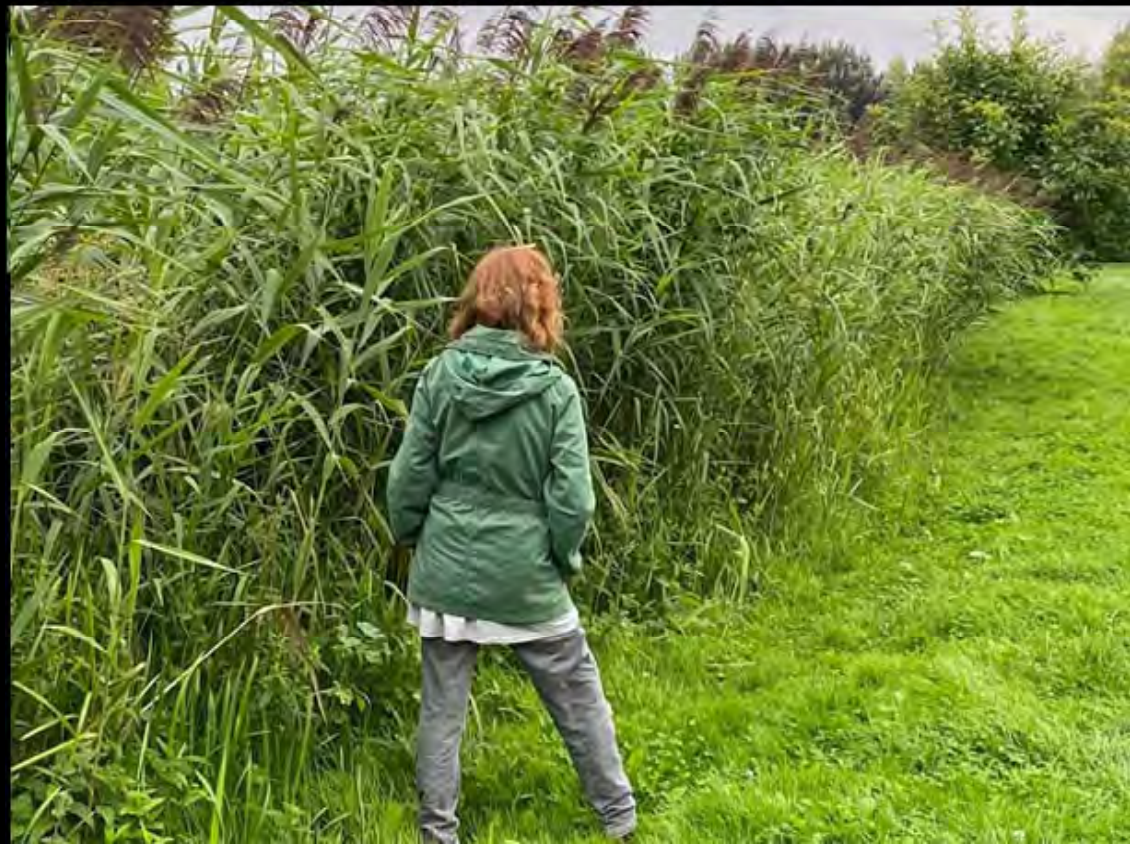
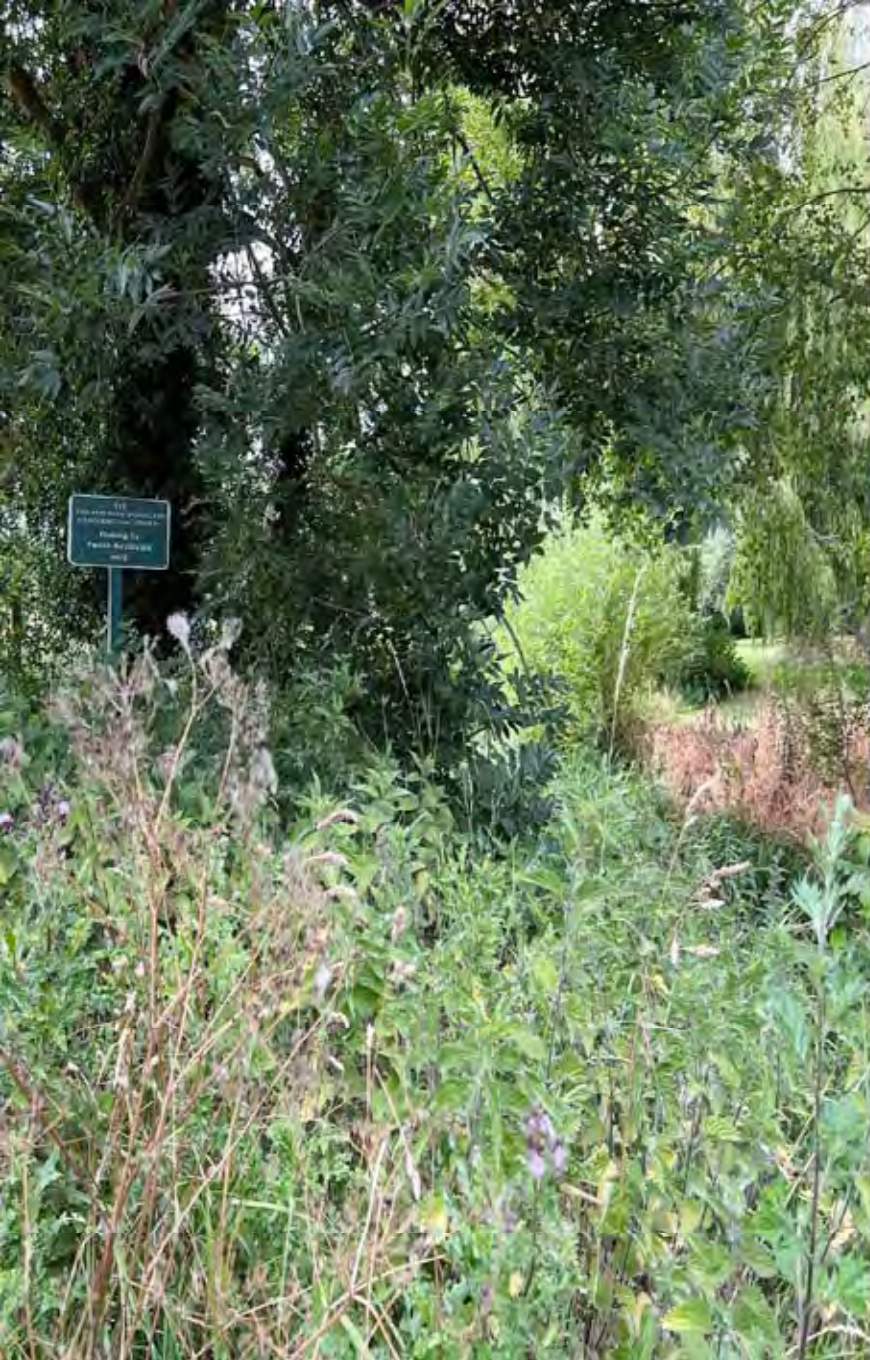
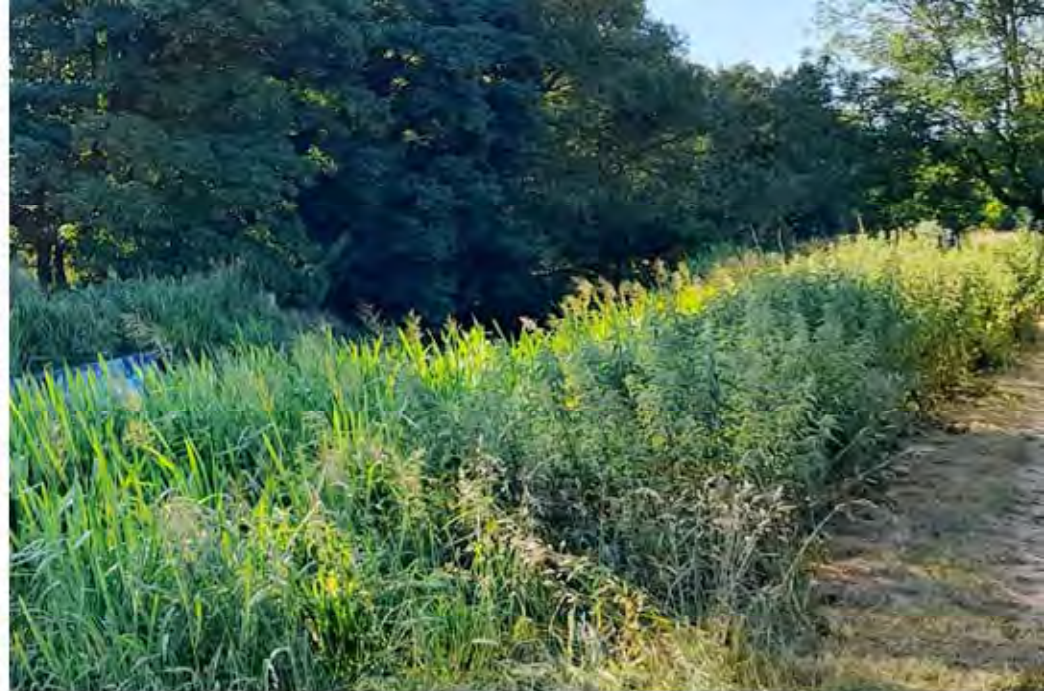
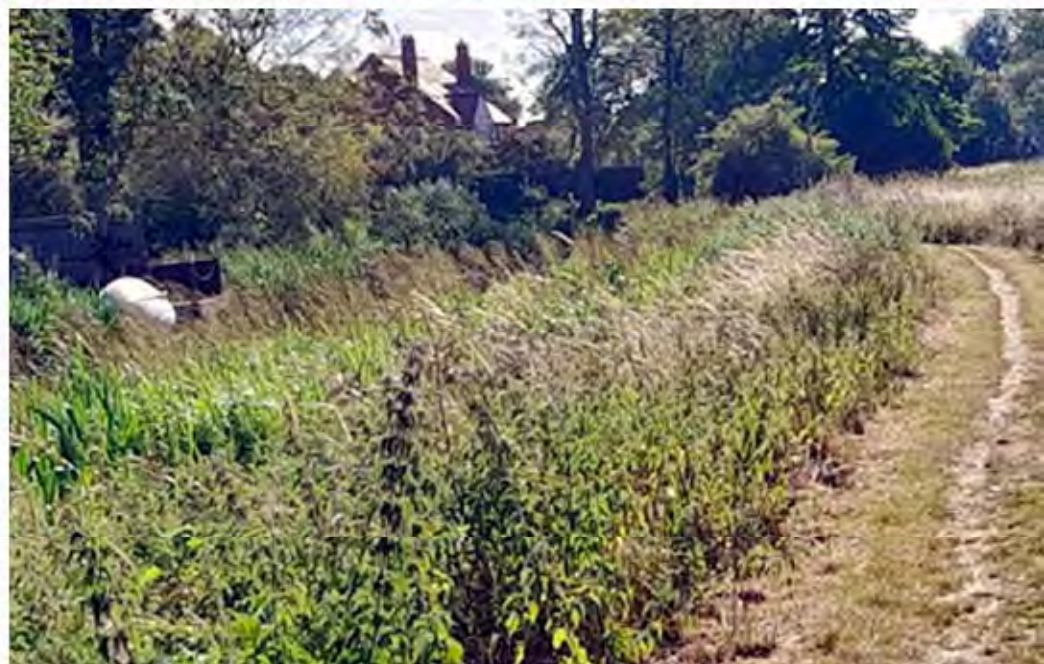
Fishing is permitted on the south bank too, but again access isn't available
