# RIVER STOUR, NAYLAND

**BUT A RIVER IN NEED  
OF MAINTENANCE**

## The River Stour at Nayland; from the A134 tunnel to the Abell Bridge.

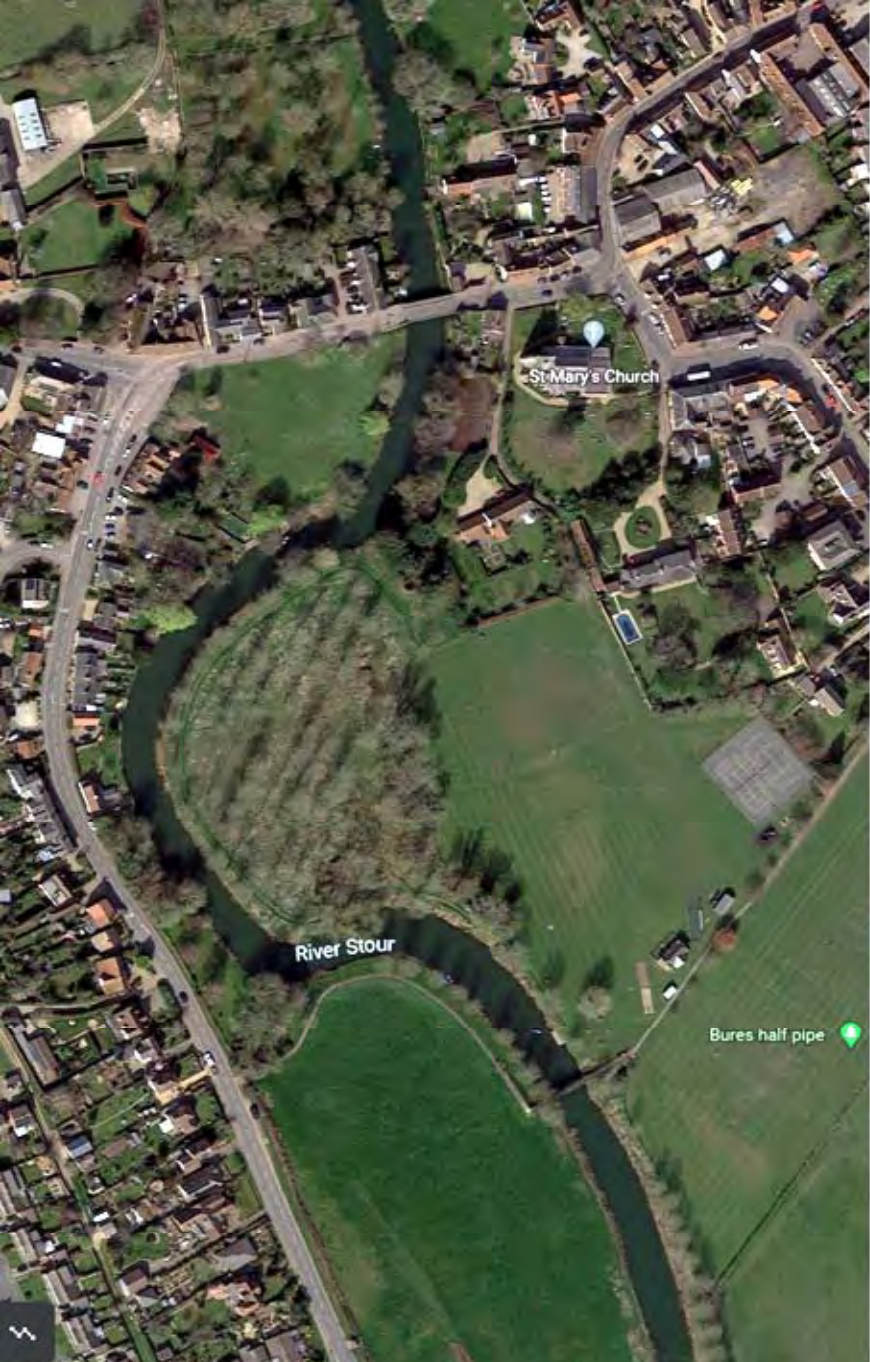
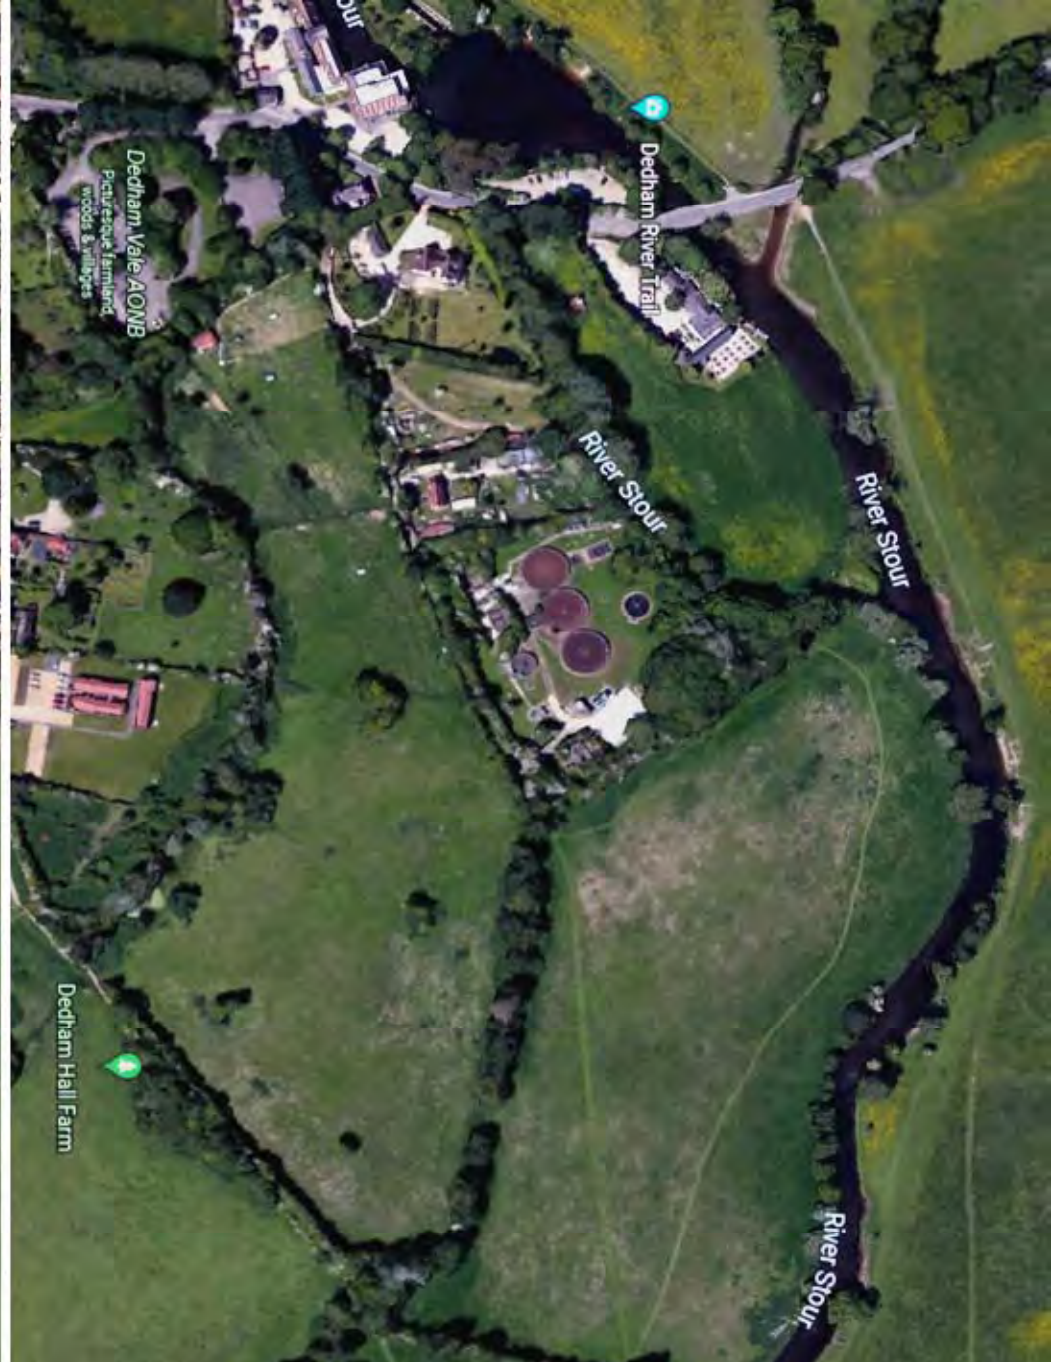
The villages of Bures upriver (left) and Dedham downriver (right) do not have this problem with reed type vegetation

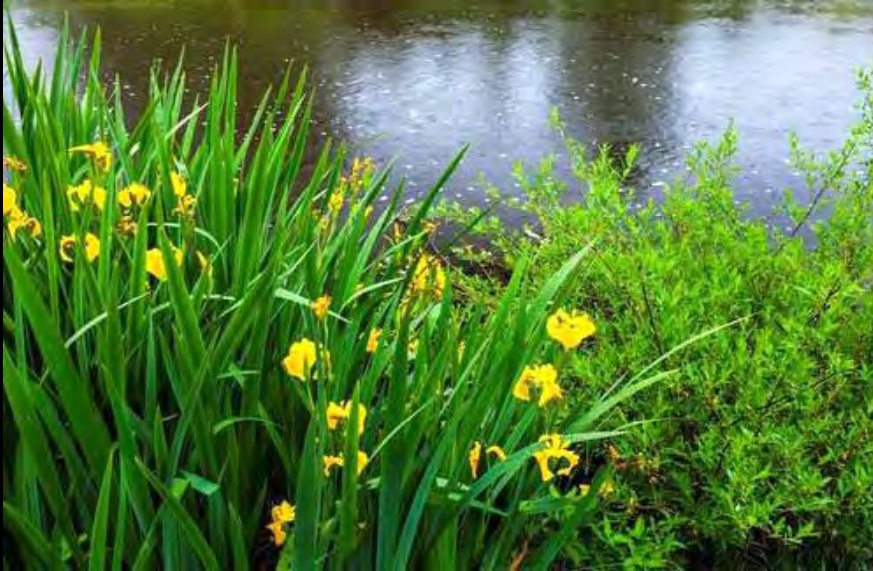
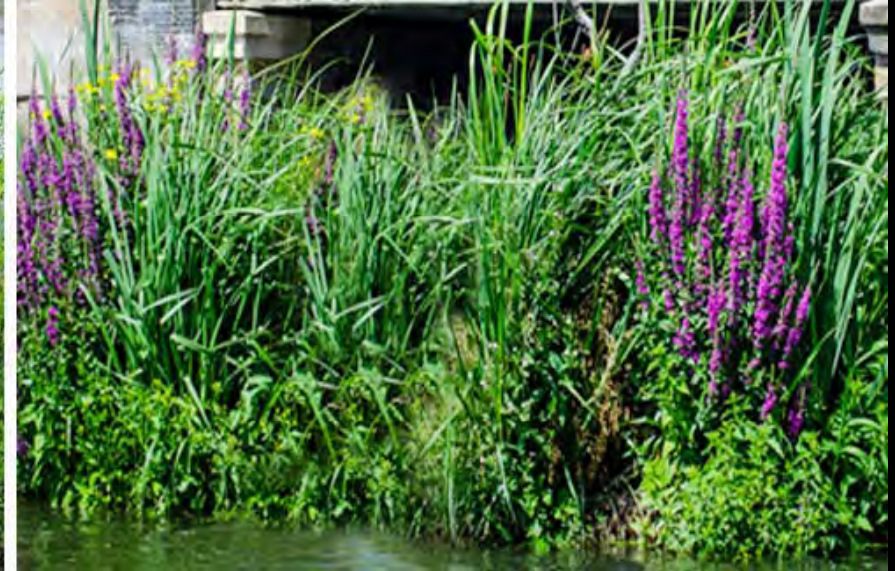
*Above: examples of plant biodiversity*

Reeds, reeds and more reeds is not biodiversity; where is the variety of flora to encourage more diverse fauna? Purple Loosestrife, Yellow Flag, Bisort, Stachys, Butomus, Marsh Marigold and others cannot compete for space among the brutish reeds.

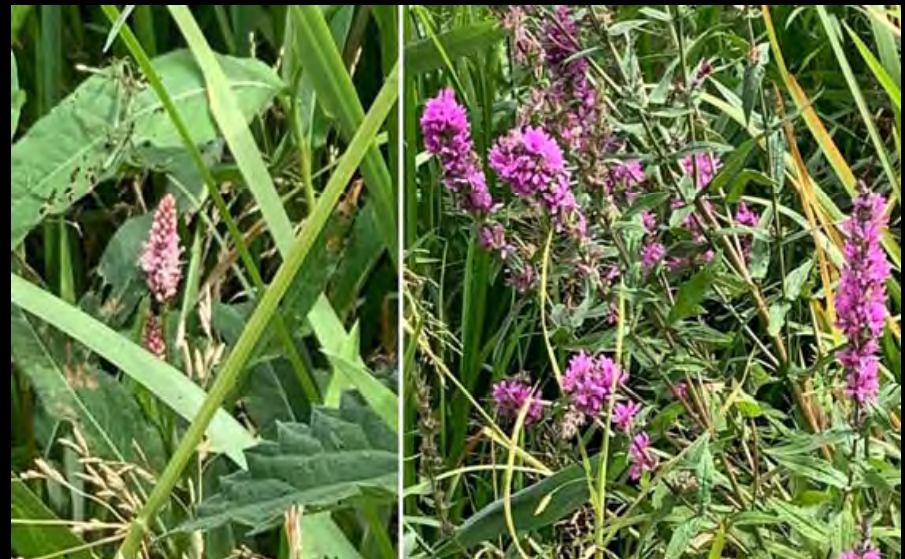
After the Friends of Caley Green exercised a little reed control there have been signs of other species (*Bisort & Loosestrife*) trying to establish.

This cannot happen while reeds dominate.

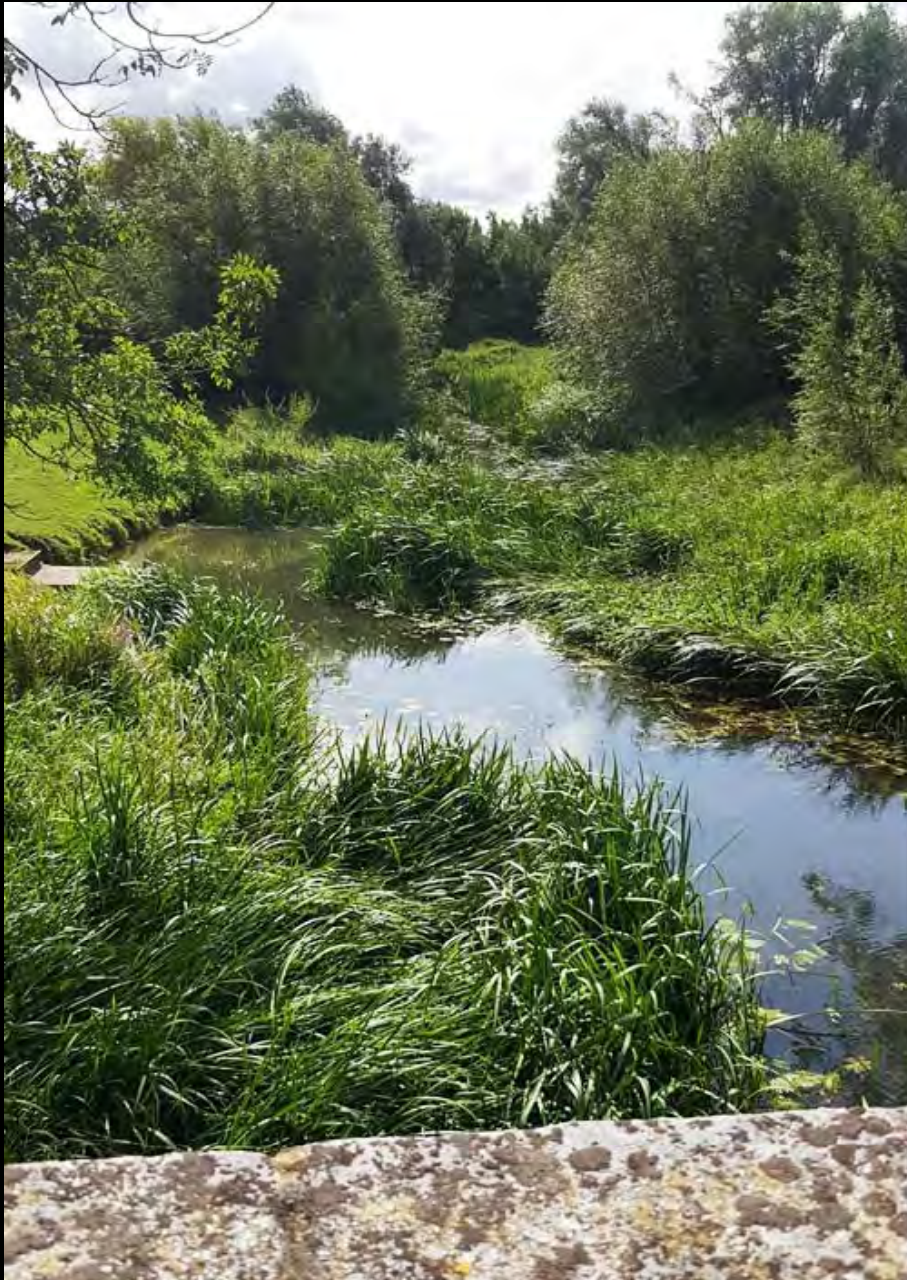
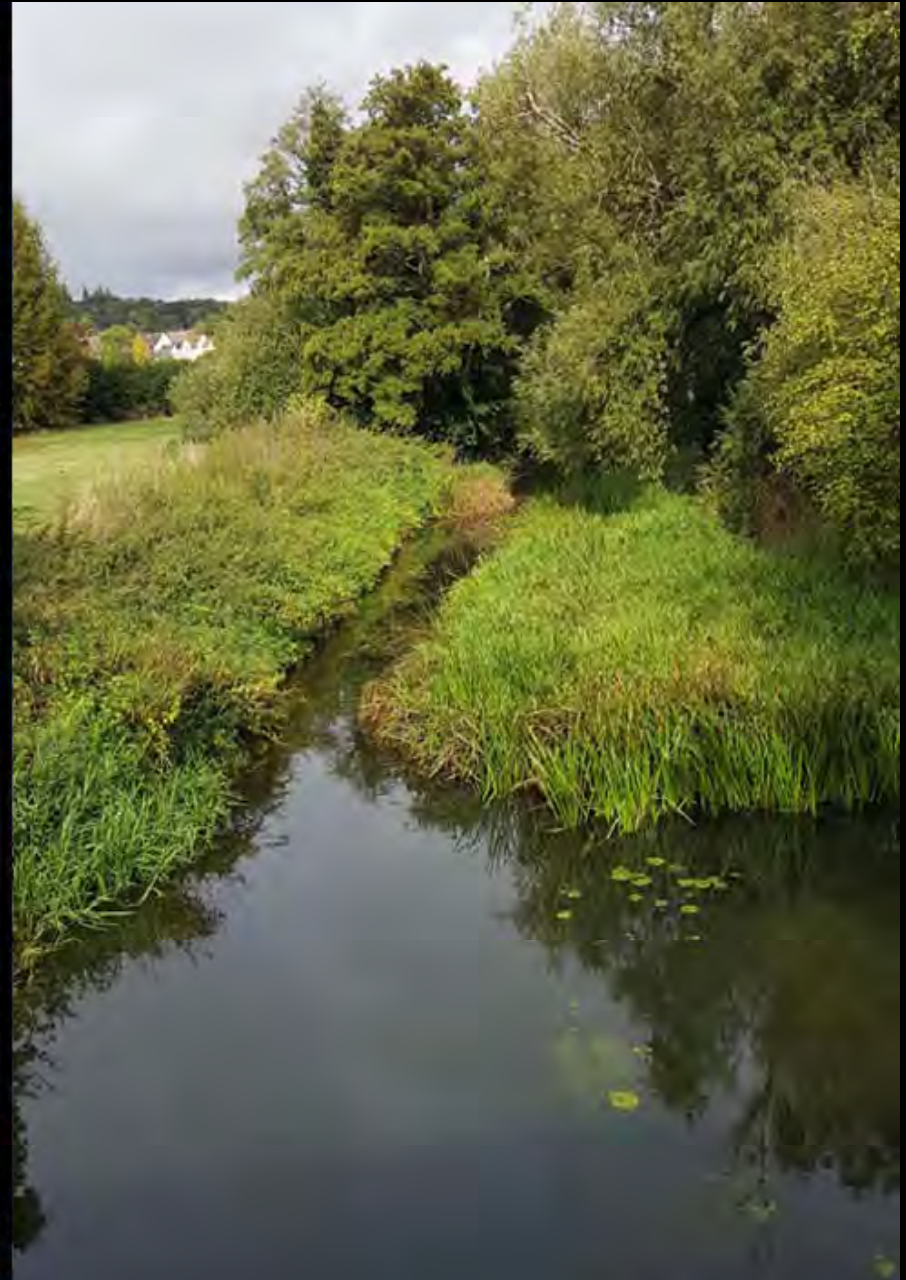
# Our River Choked with Reed Type Vegetation

Navigation, even in a narrow canoe or paddleboard, has its challenges

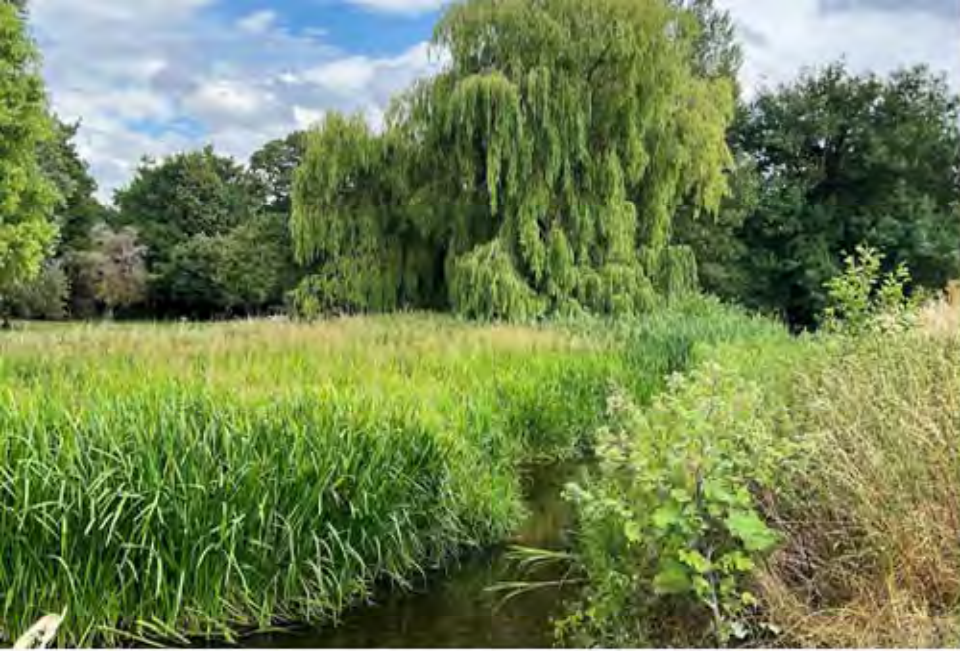
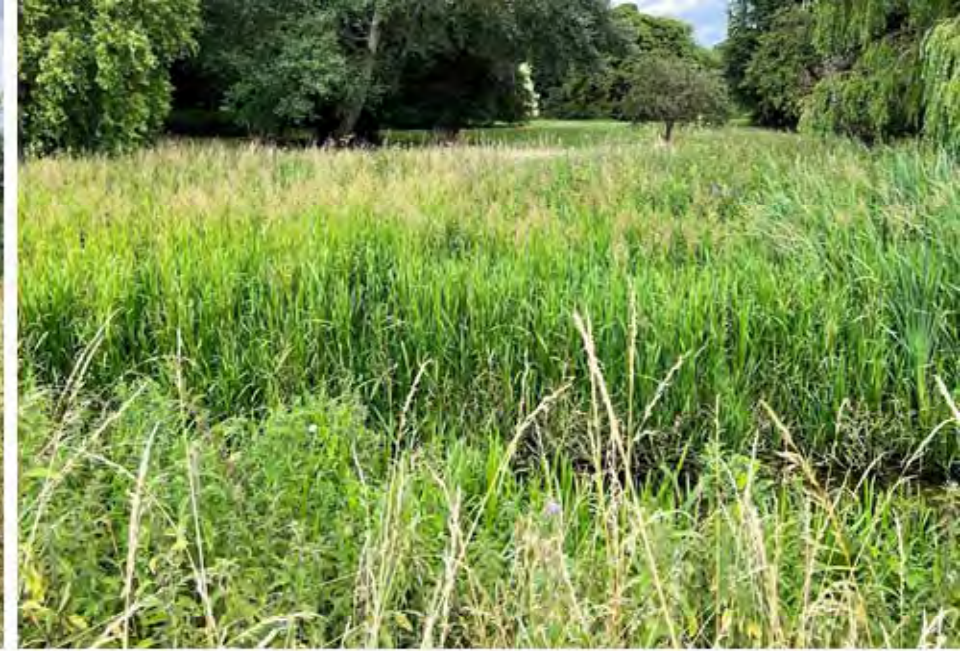
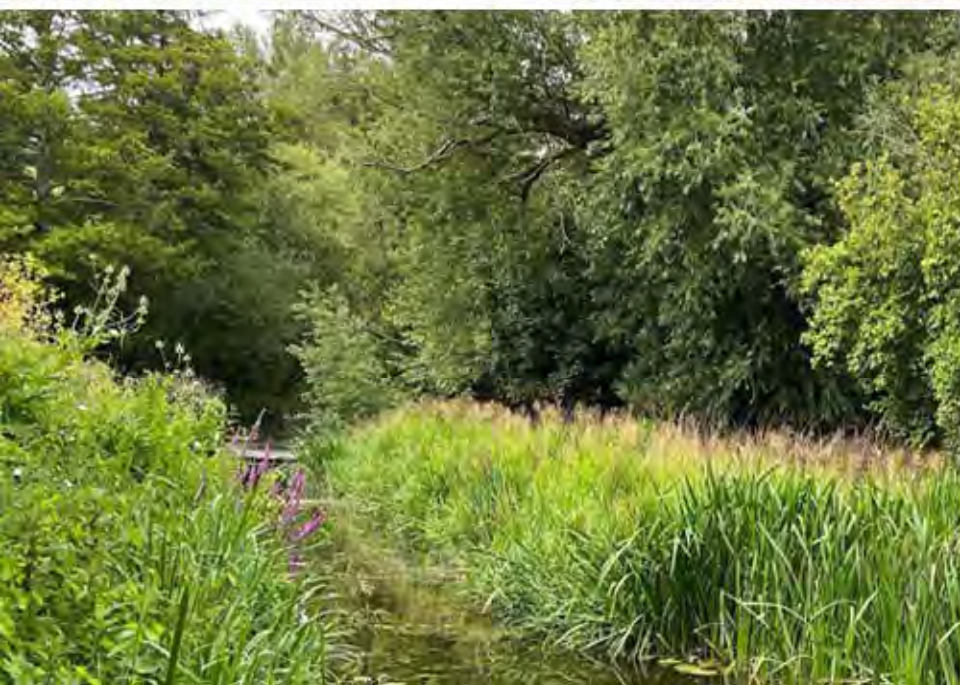
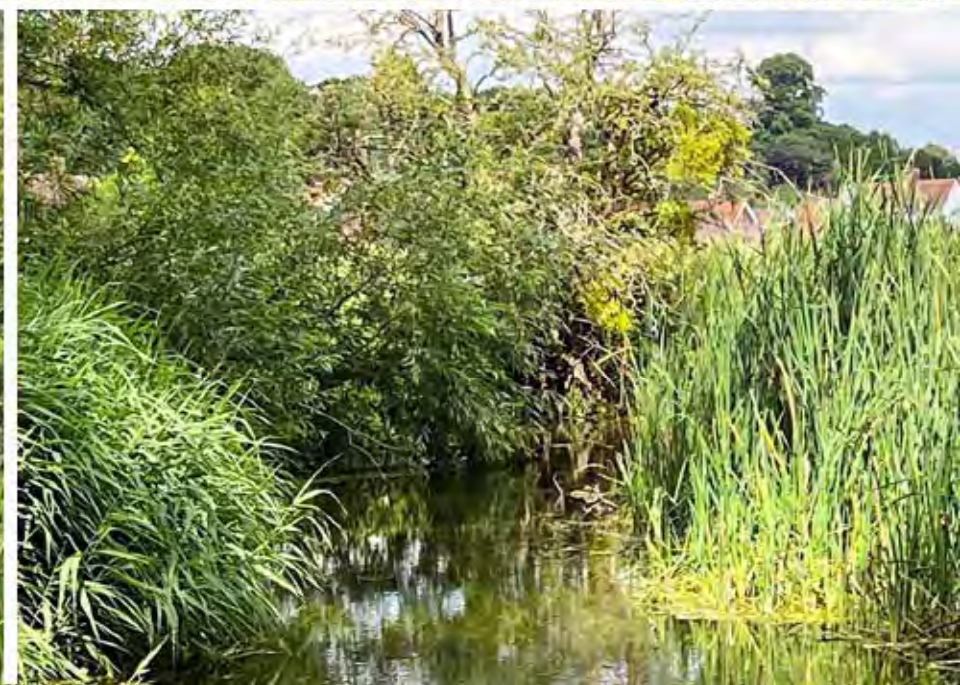
The main river in 2022: just a narrow waterway through a dense jungle of reed type vegetation, hardly a Right of Navigation.

Silt removal to help riparian owners control reed growth and enable other plant species to establish; this would also increase the capacity of the river and reduce flood risk
